Condition Assessment

Great Lakes Navigation Structures Condition Assessment

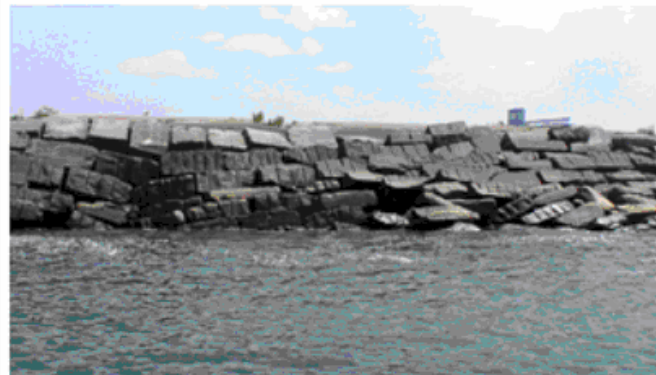
Structural Rating	Description	Photo Example
25 to 39	Many armor stones have either shifted or been displaced by greater than a foot. There may be significant bridging between armor layers along with the loss of individual armor stones within the reach.

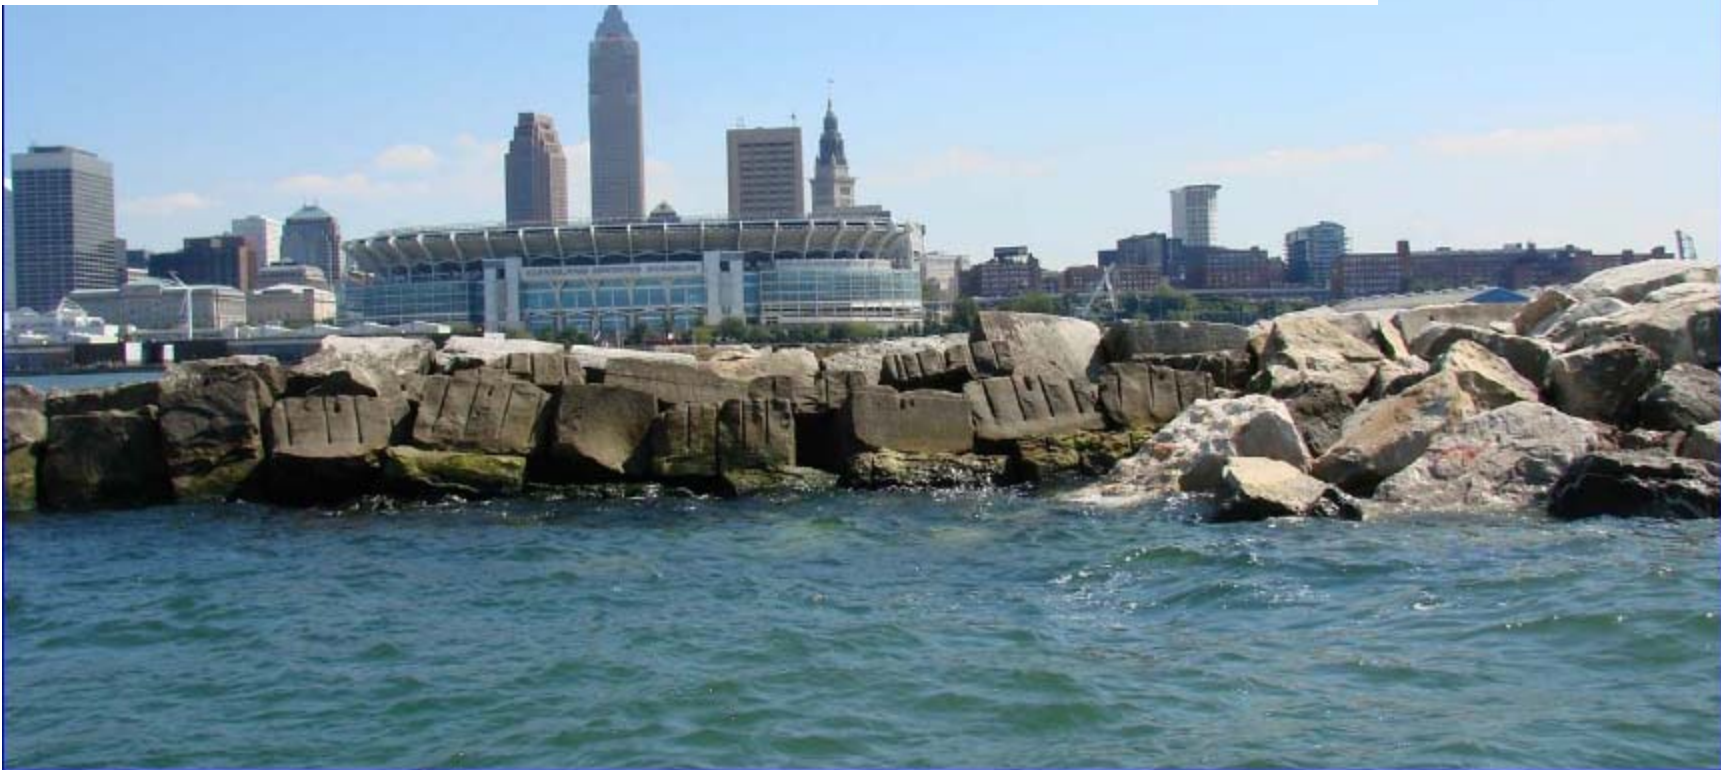
STATION 84+00 – PREVIOUS REPAIR AT RIGHT SIDE OF PHOTO

Cleveland Harbor, Ohio – Damage Photos

SI = 5.8

Comment Number	Suggested Action	Station Location(s)	COMMENTS AND SKETCHES
①			Quality of stone blocks is moderately impacted, but stones are not functioning as a hard-up structure.
②			Slopes have slumped / flattened

- Recommended Repair Reach:
 - 84+00 – 94+00 (minimum) repair should extend to old light block at 106+29
- Total Length of Repairs = 1000 to 2229 feet
- Recommended Repair Method: Rubble mound stone overlay
- Estimated Cost of Repairs = \$2.5 – 5.5 M
- Structural Index = 5.8

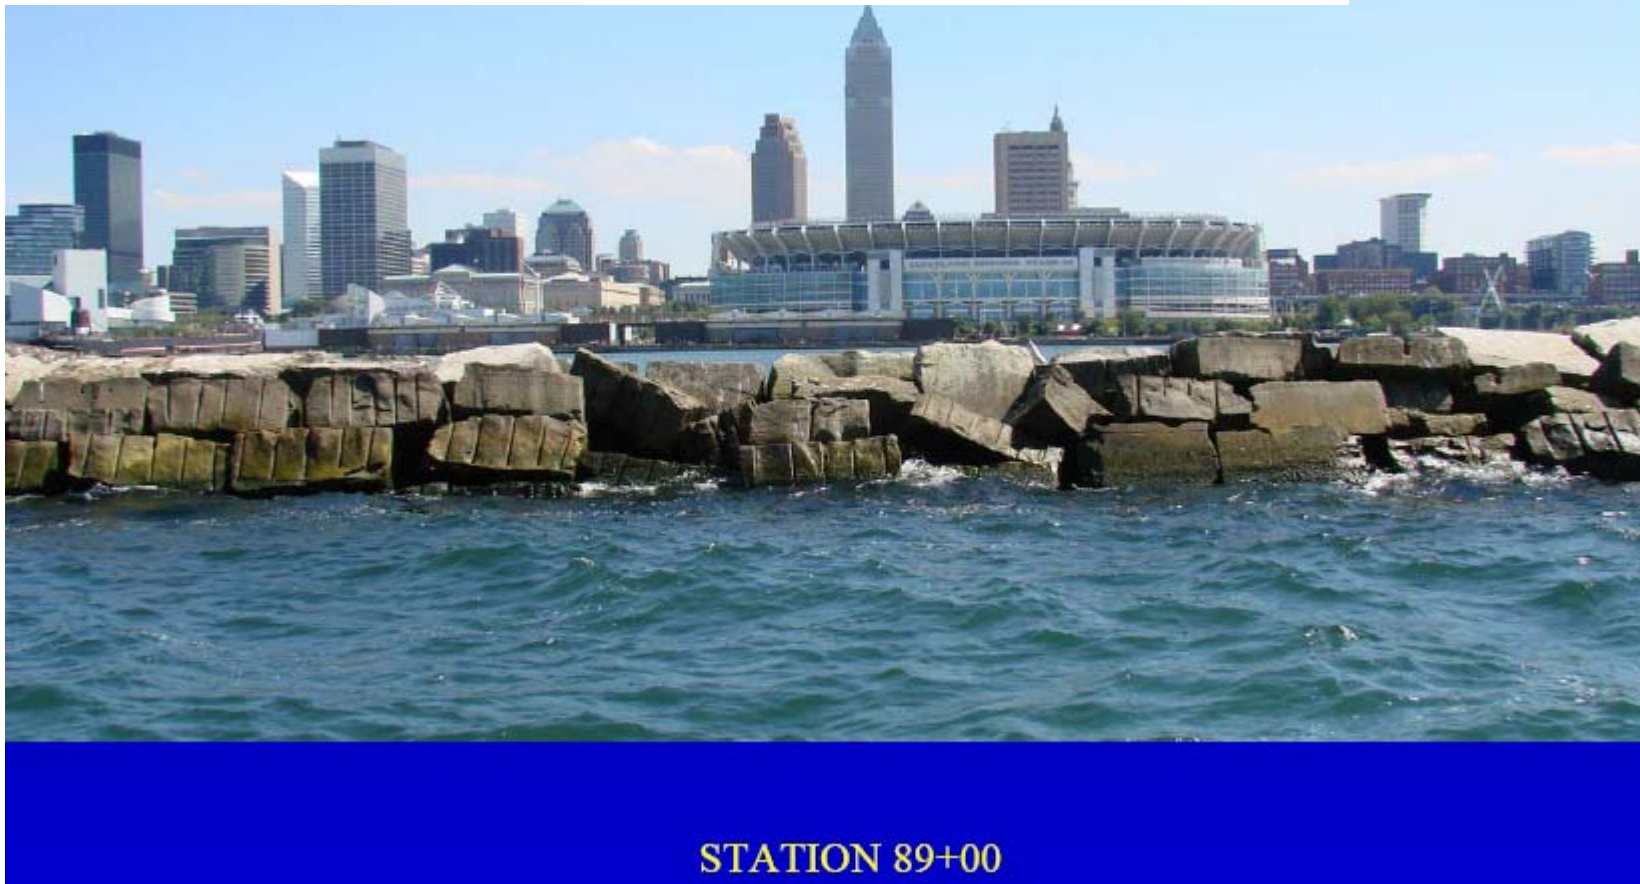
Cleveland Harbor, Ohio – Damage Photos

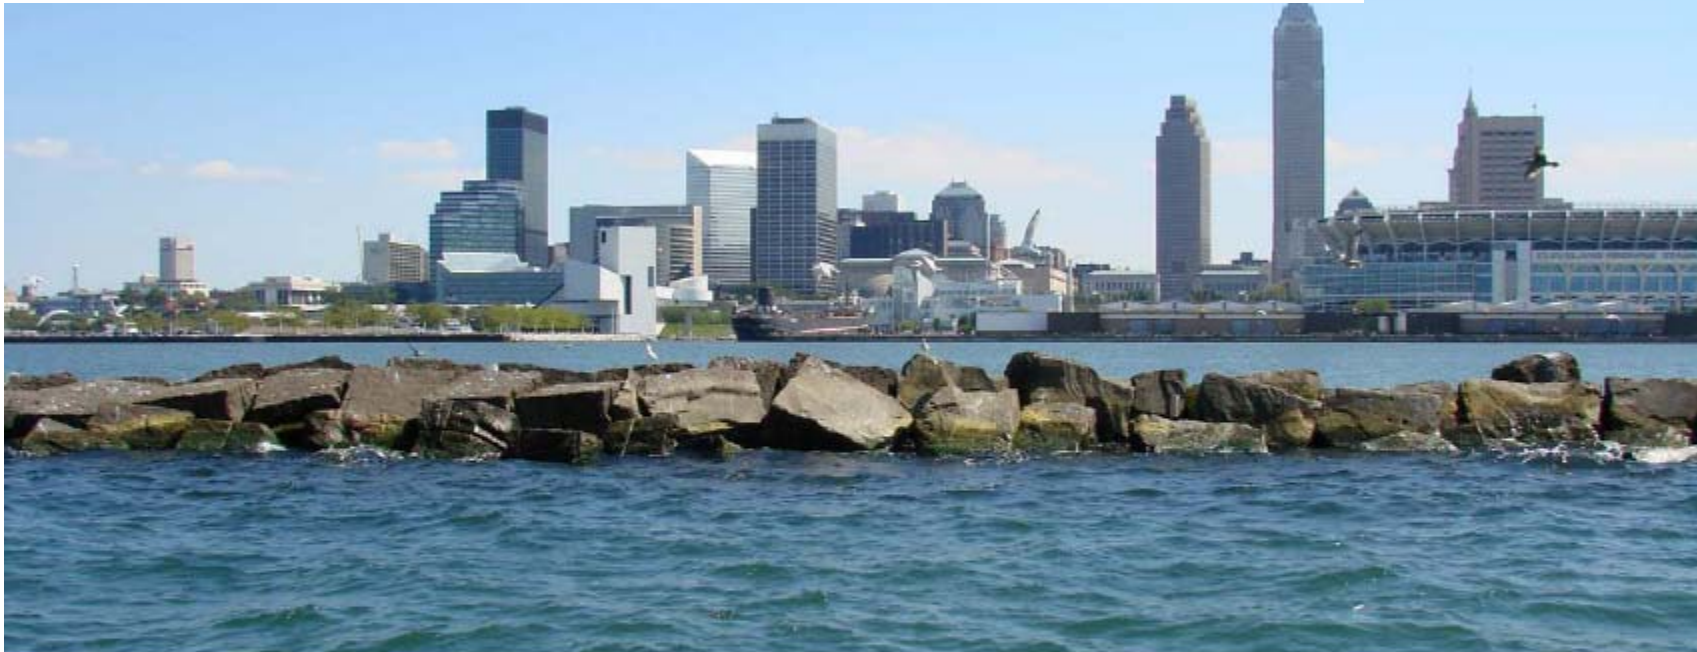
STATION 94+00

Cleveland Harbor, Ohio – Damage Photos

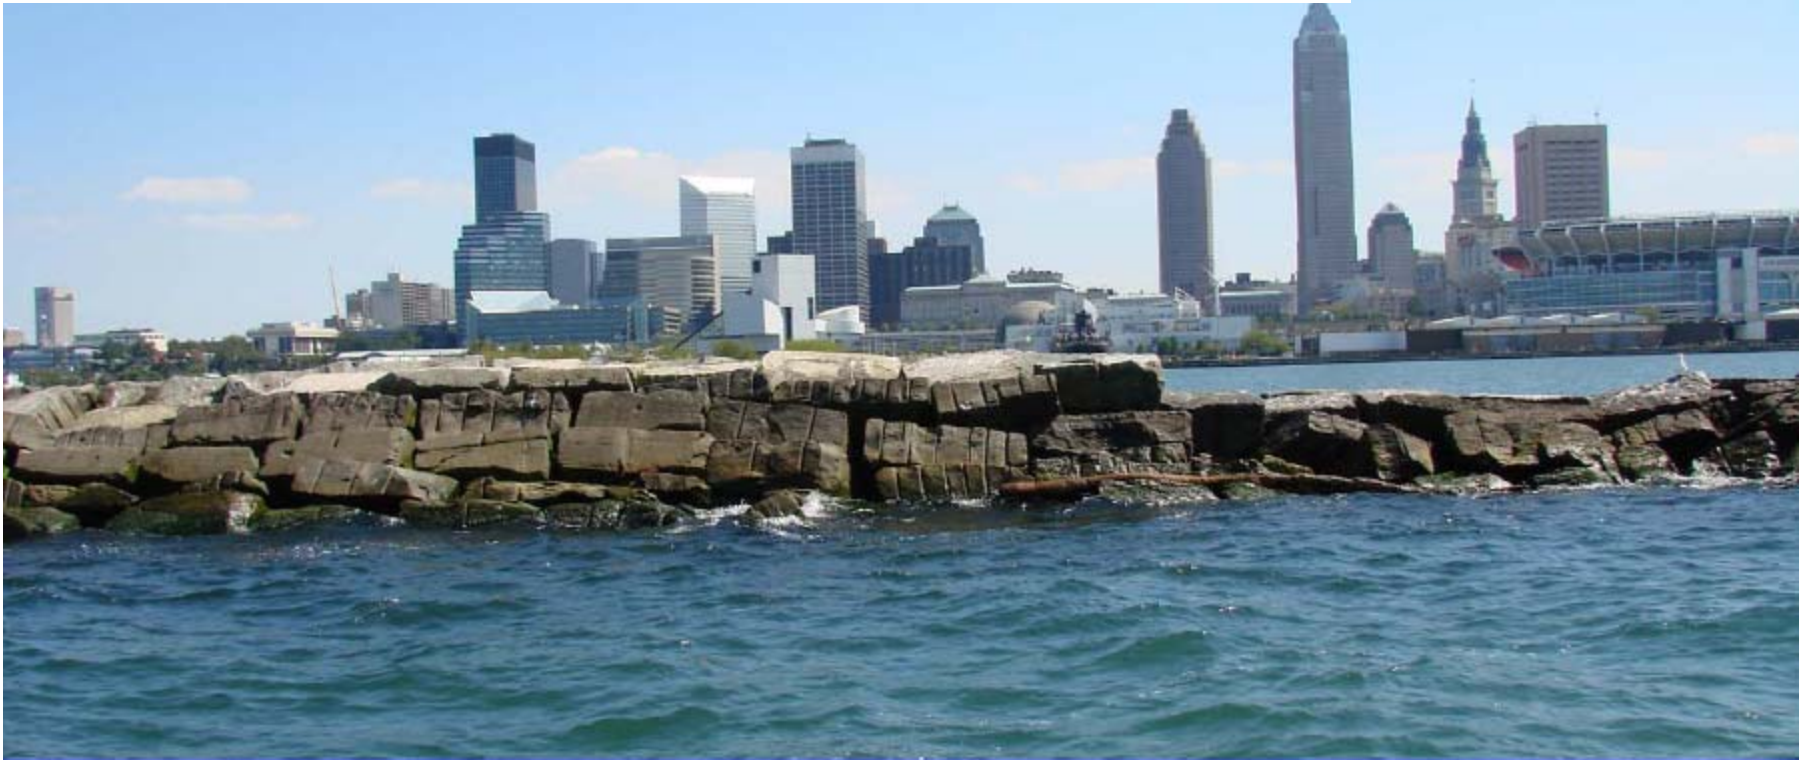
STATION 98+35

Cleveland Harbor, Ohio – Damage Photos
